Water Compliance Inspection Report

***NPDES
Inspection Report***

***Verallia
Saint-Gobain Containers, Inc.
Seattle, WA***

August 16th, 2012

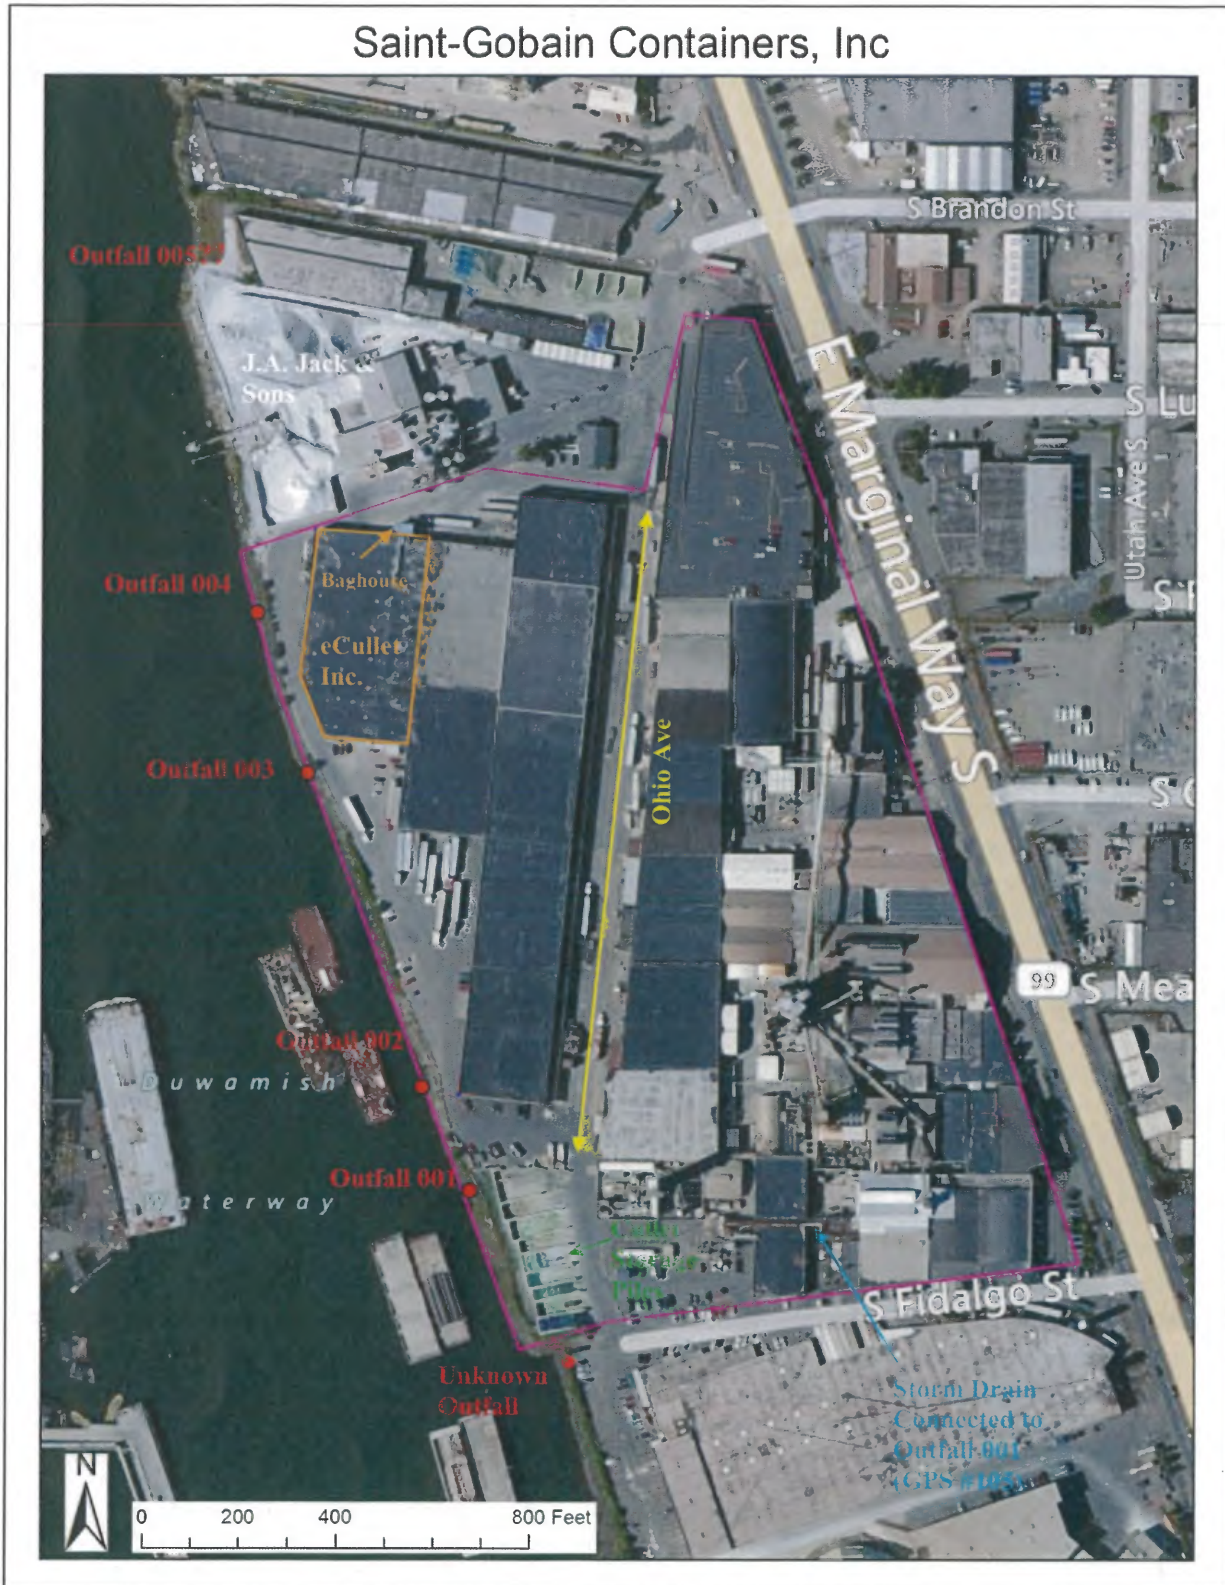
Site Maps

Map 1: Aerial photo with approximate facility boundaries (purple), outfalls, Ohio Ave, cullet storage area, and eCullet Inc. building identified. In addition, GPS data was collected at the location of a storm drain believed to flow to Outfall 001. It appears to be the only storm drain on the eastern side of the facility (and Ohio Ave). Map was created using ESRI ArcMap 10.0. Outfalls were mapped by georeferencing **Map 2** on top of the above aerial image.
